KCI Technologies, Inc. (KCI) performed a visual inspection of the vehicular bridge that is owned and maintained by the Key Marco Community Development District (CDD) in Collier County, Florida on October 31, 2022. This bridge inspection and evaluation report summarizes the findings of the inspection and provides recommendations for maintenance repairs. The bridge is considered safe to carry legal traffic loadings, but short term and long maintenance repairs are recommended to prevent further deterioration and prolong the service life of the bridge.

WHISKEY CREEK BRIDGE Inspection Report

TAB 2BRIDGE INSPECTION FIELD REPORT

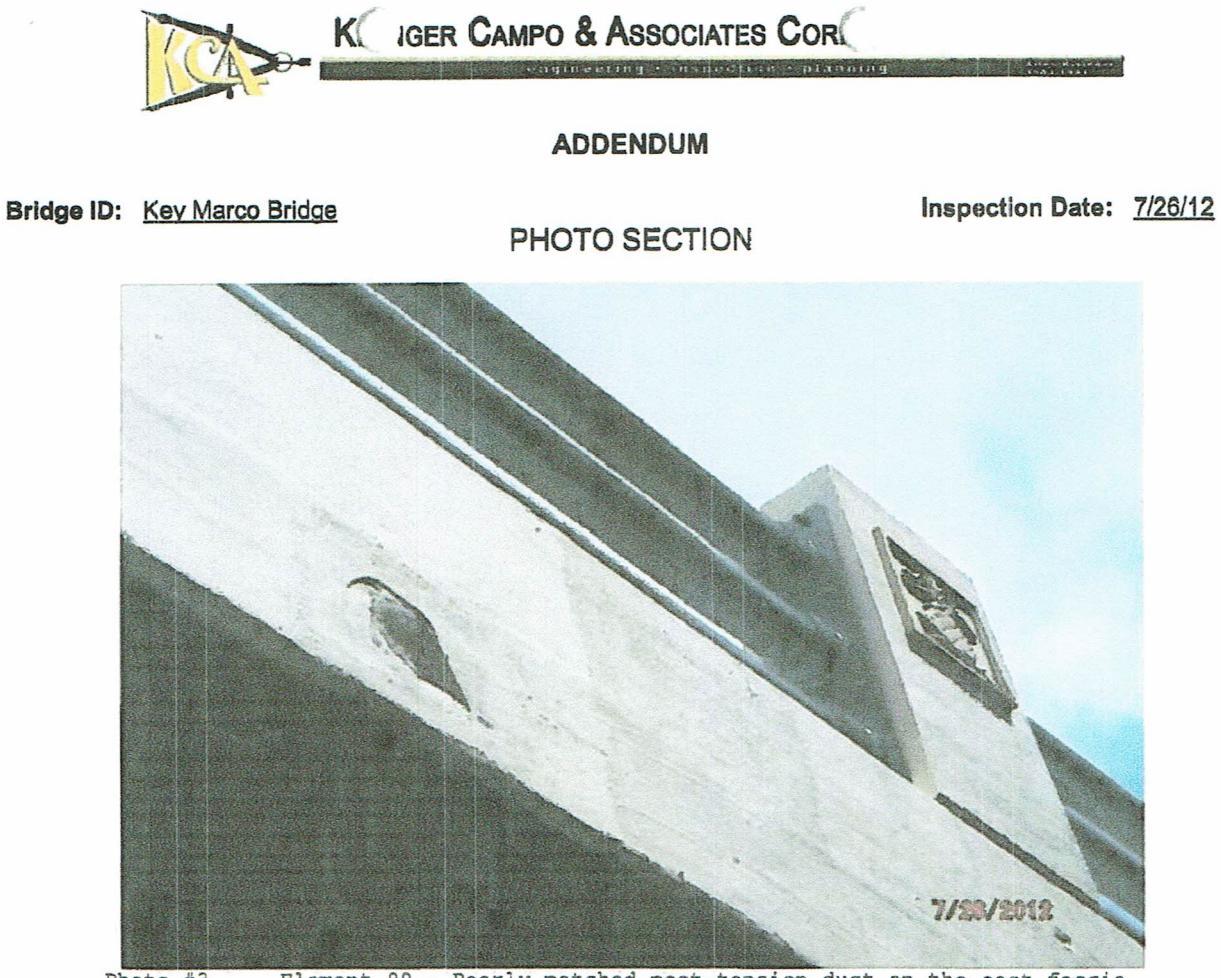
Photo #3 Element 99 - Poorly patched post-tension duct on the east fascia of Slab Unit 11-9

Repair the poorly patched transverse post-tension ducts on the east fascia of Slab Units 10-9 and 11-9.

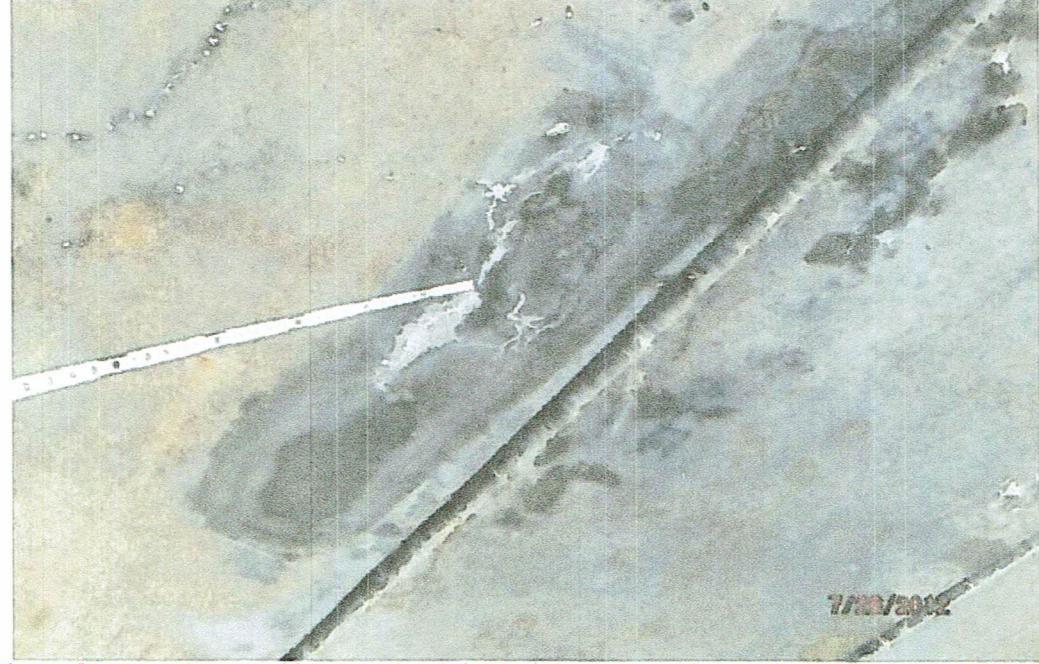
The east edge of Slab Unit 13-3 has a patch with minor shrinkage cracking and efflorescence, approximately 9ft. from Bent 14. Refer to photo 4 in the attached addendum.

Photo #4 Element 99 - Patch with shrinkage cracking and efflorescence on the underside of Slab Unit 13-3 at the east edge

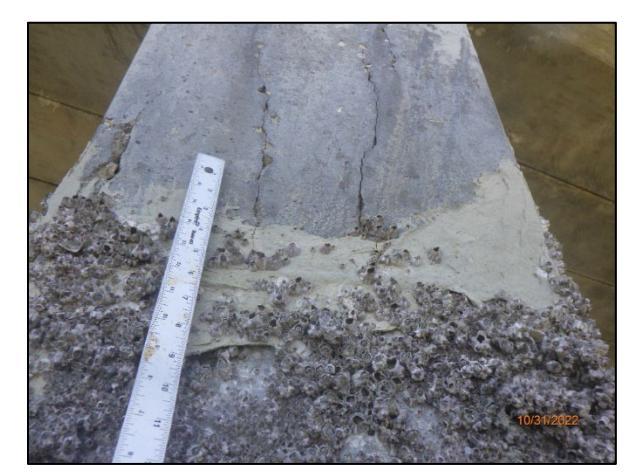
Photo 3

CS-3 1110 Pile 9-6, all faces from splice up have intermittent vertical cracks, up to 4ft. L x 1/16in. W - INCREASE. (1EA)

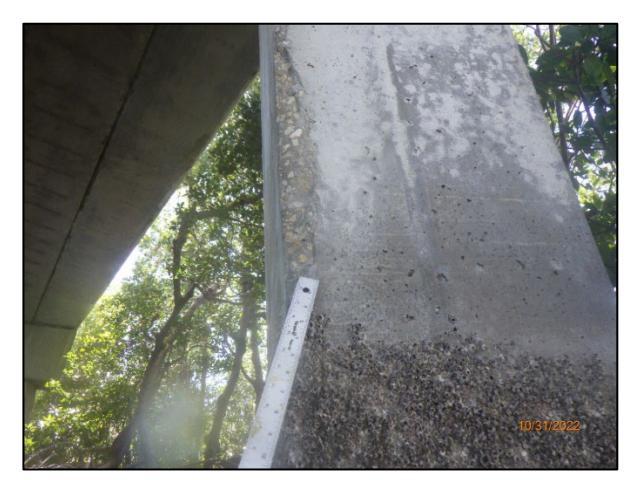
Photo 4

CS-3 1080 Pile 7-1, northeast corner at cap has a spall, 10ft. H x 3in. W x 3/4in. D. (1EA)
